American River Community Hall

Preliminary Condition Assessment Revision A 17/8/07

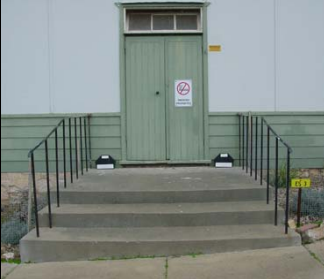
I General Interior	Description	Condition	Action	Cost
Structure Access	NA Disability access is not available		Remove steps, provide Ramp to main entrance. modify door

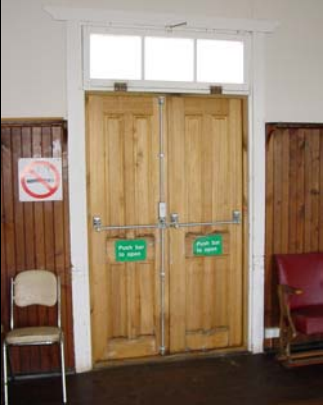
3 Hall	Description	Condition	Action	Cost
Access	Refer Interior			
Structure	North west Corner	Appears to be small long term subsidence	Monitor	TBA
Finishes				
Ceiling	Panels (possibly masonite) with cover battens	Good		
Walls	Timber panelling to 2 m, Panels (possibly masonite) with cover battens over	Good		
Floor	Polished (?) hardwood timber	Good	Maintain	
Ext. Doors	Front door hardware	Inappropriate	Replace	Refer General
	Side doors	Show signs of leakage. Hardware inoperable (roped closed) Some rot to base of frames	Replace doors and hardware. Ensure functional URGENT (2 off) Repair	\$5,000 \$ 600

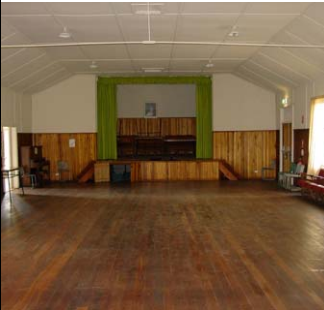
4 Stage	Description	Condition	Action	Cost
Access	Stairs	Stairs are non compliant. Disability access unavailable	Replace stairs (3 off). Provide ramp	\$6,000 \$5,000
Structure	Floor	Supported on stumps buried in ground. No ant caps present	Regular condition assessments

Space under floor used for storage	Fire hazard and impedes termite inspections	Remove	\$ 500
Finishes				
Ceiling	Panels (possibly masonite) with cover battens	Good		
Walls	Timber panelling to 2 m, Panels (possibly masonite) with cover battens over Softwood (untreated)	Good		
Floor		Good	Seal	\$1,500
Ext. Doors	NA			
Int. doors	Hollow core	Not suited to use.	Replace door (1 off)	\$ 800
Windows	NA			
Fitments	Curtains	Assumed not fire rated	Replace	\$3,000
			TOTAL	\$16,800

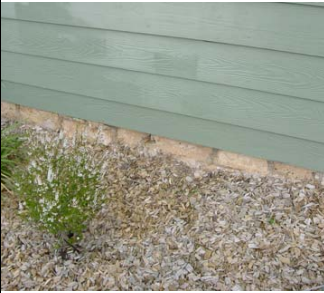
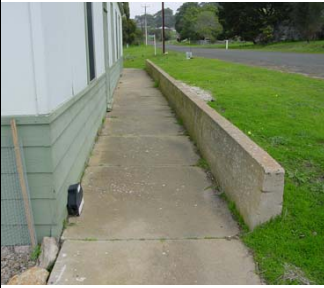
\$43,000
Gutters	Steel with various finishes	Replaced at various times	Replace with roofing	\$4,000
Walls	Asbestos cement sheet and boarding with timber cover battens Northern portion built on stone dwarf walls.	Sheets chipped and cracked in places allowing weather penetration. Battens rotted in places Signs of rising damp	Optional repair or replacement Investigate and treat	TBA \$5,000 \$5,000
	Retaining wall to west	Could be considered tripping risk	Install handrail or similar
